How long will a Bosch motor last?

A question often asked on forums, and to us at Performance Line bearings! How long should a Bosch active or Performance Line motor last? How many miles or kilometres should it do?

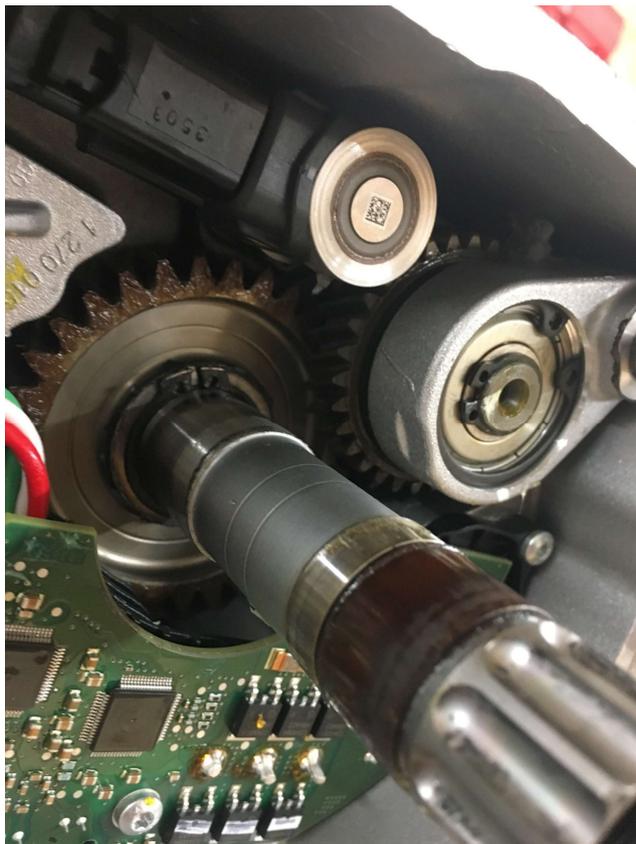
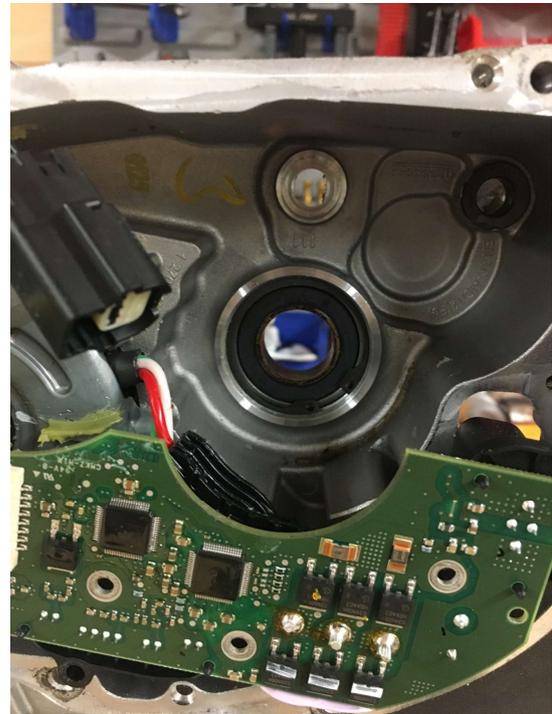
This first pictures below show

the insides of the motor. You will note that it is as clean as the day it came from the factory. There is a very slight discolouration of the grease on the steel gears and this is caused by the small amount of water that has crept under the crankshaft bearings. You can also see the rust on the end of the crankshaft where the right-hand crankshaft bearing sits. (this could probably be cured by using a smear of silicone grease when the motor is assembled as we do at Performance Line Bearings).

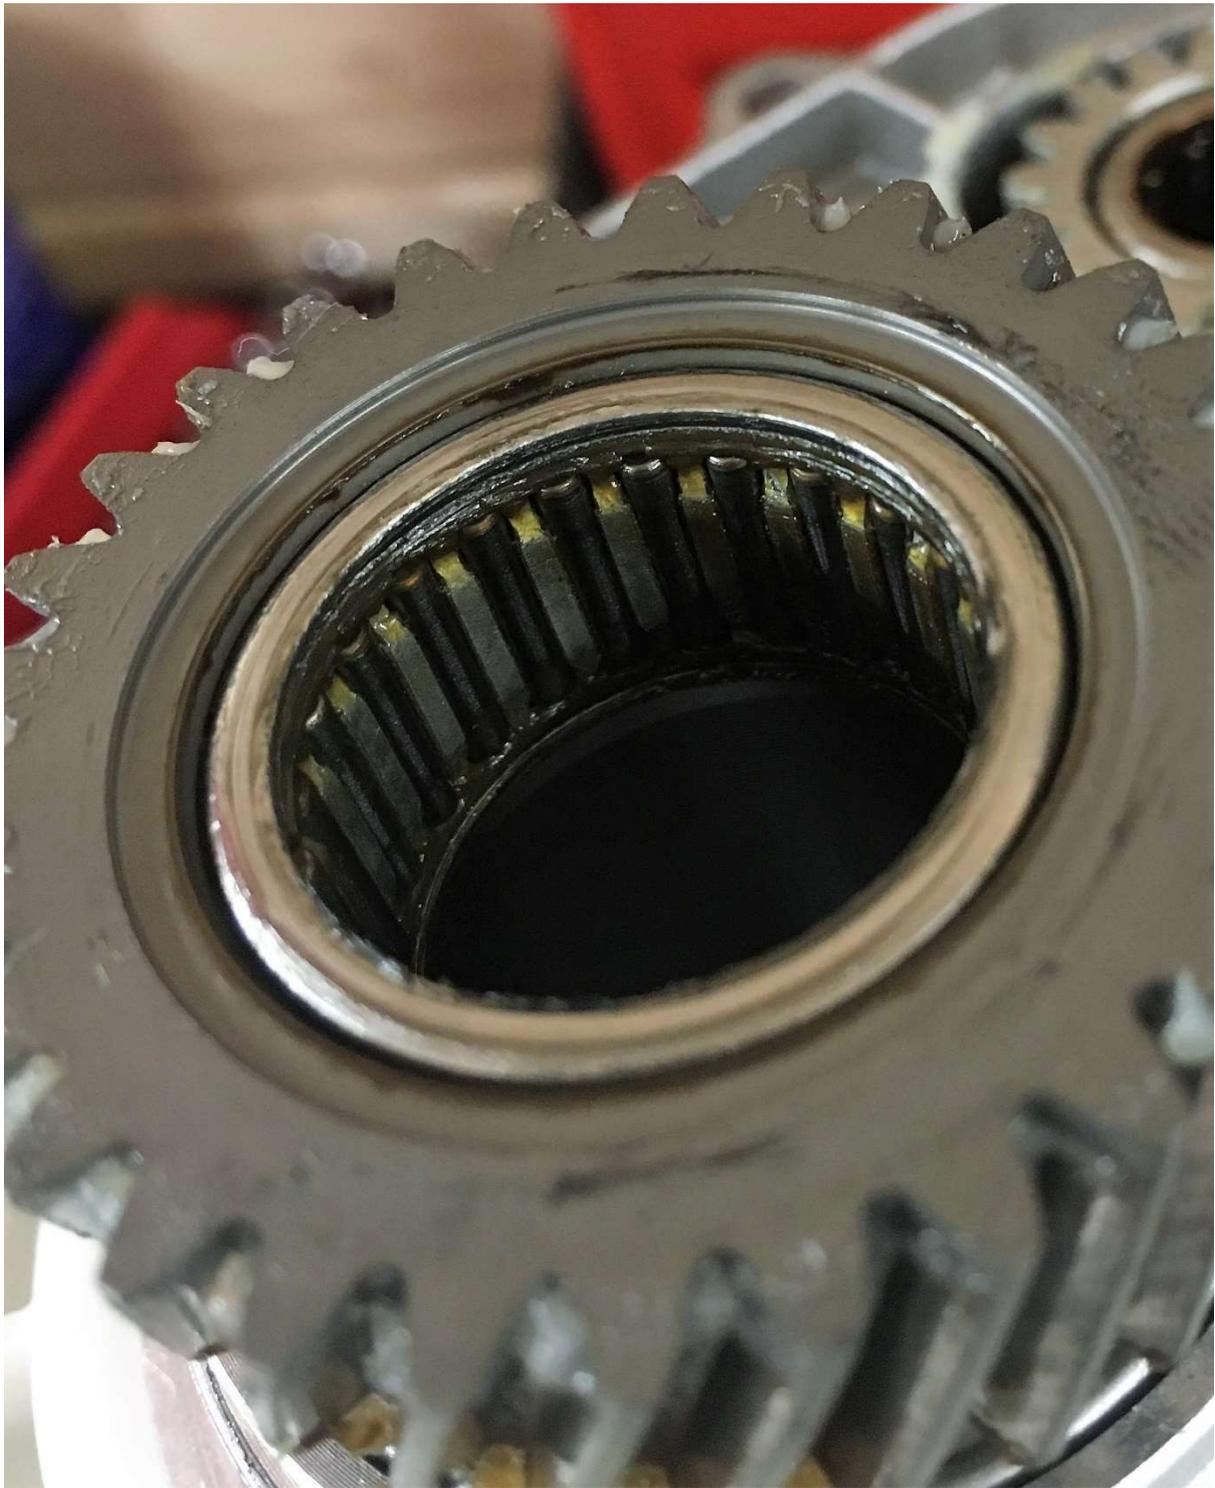
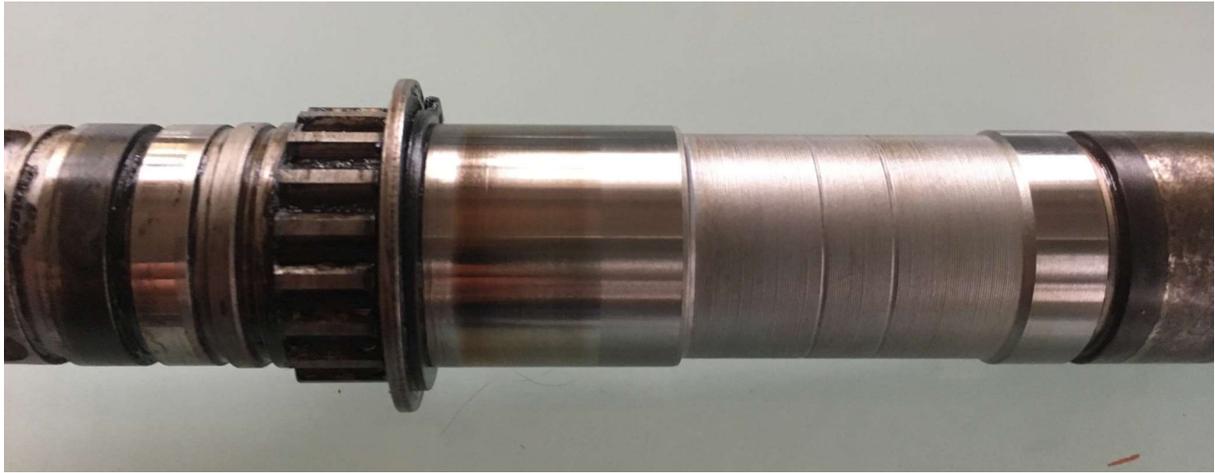
One of the first things I noticed was the main motor drive gear needle roller bearing had worn the needle rollers to the point that the roller cage that supports the needle rollers was starting to wear

away on the crank shaft. Discolouration could also be seen on the crankshaft because of this bearing getting hot through friction.

We replaced all the bearings in this motor and fitted a second-hand motor cover to cure the worn components. The motor is now back in the customers bike and running smooth and tight 😊

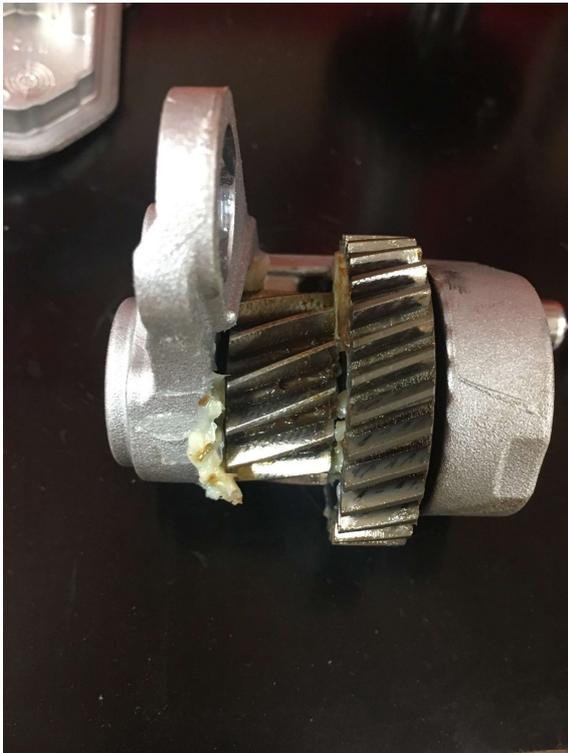
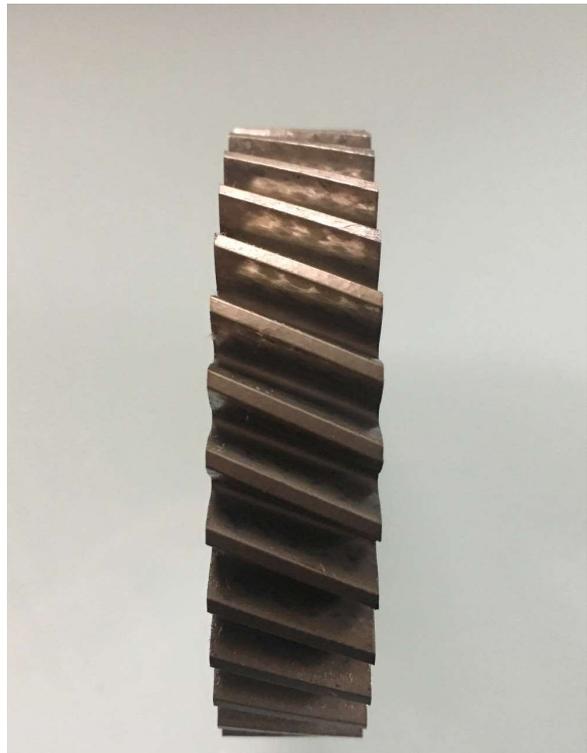
There were very little signs of wear to most of the metal and plastic gears, although back-lash (play) could be felt by rocking the crank back and forth. Some of this may have been caused by worn clutch bearings. Although, is more likely the wear of the gears overall.

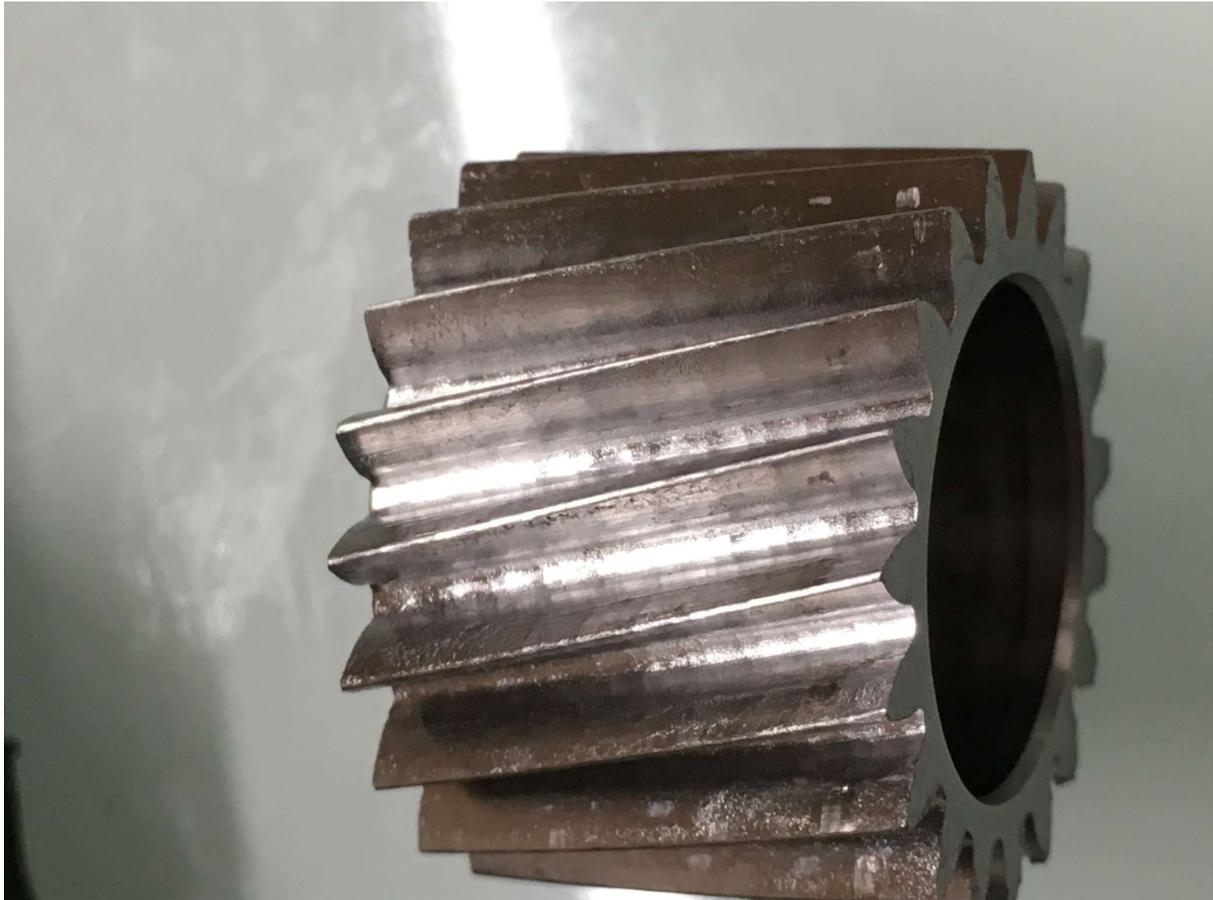
However, the small idler gear didn't fair so well and showed the most wear.

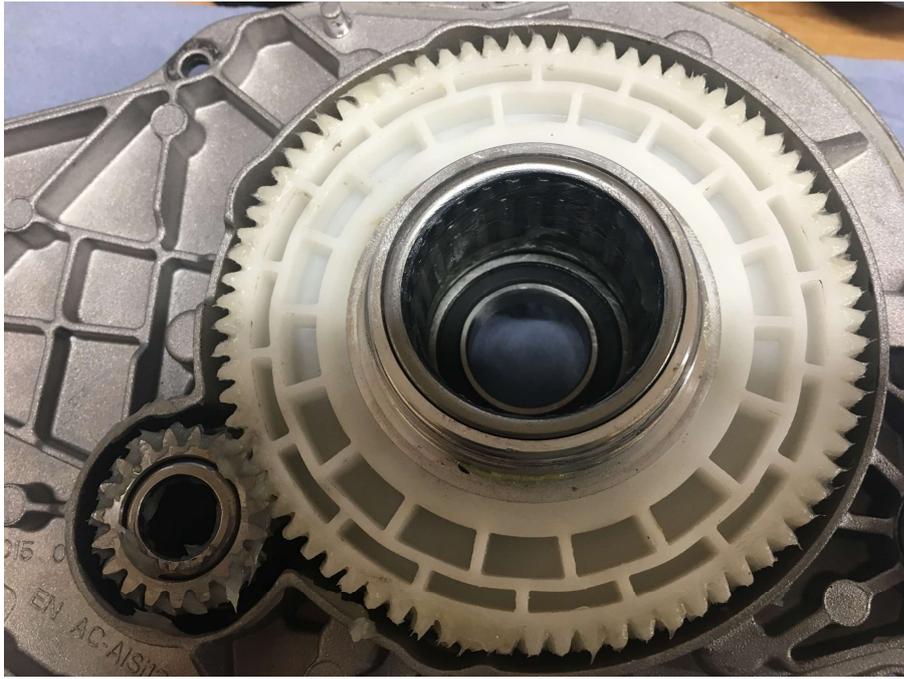
Most of the bearings were worn and felt rough! The most worrying thing and probably the detrimental thing to affect the life of these motors was the play around the right-hand crankshaft bearing and main motor bearing. (This of course can now be fixed by the cover kit that Bosch have released. If they will sell it to the general public or for bikes outside of warranty period?)

The force of pedalling for 20,000km has worn or stretched the soft aluminium of the main motor drive gear

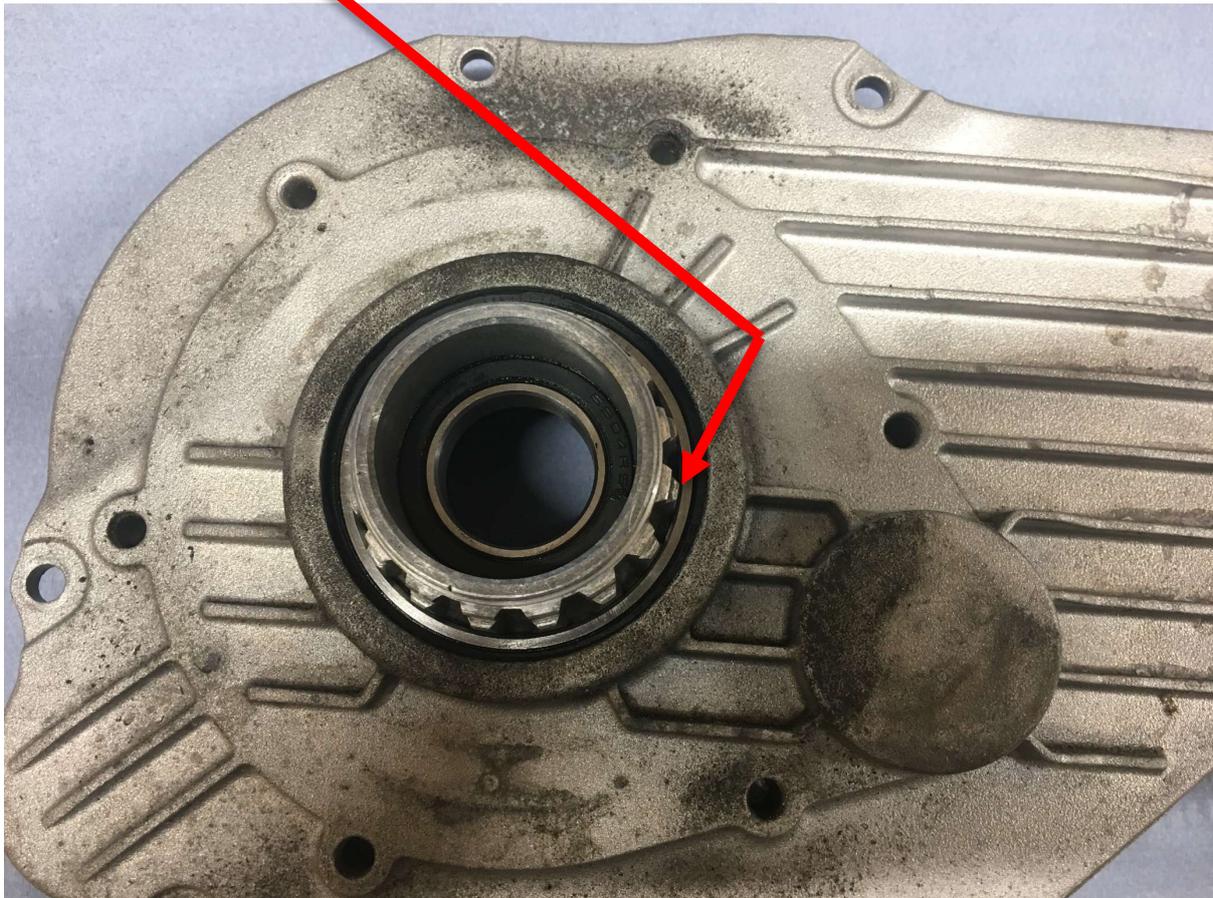
Bad wear was also here:

This wear was particularly bad and would be felt through the pedals whilst riding.
