# Shimano E8000 Bearing Change V8a

## Introduction

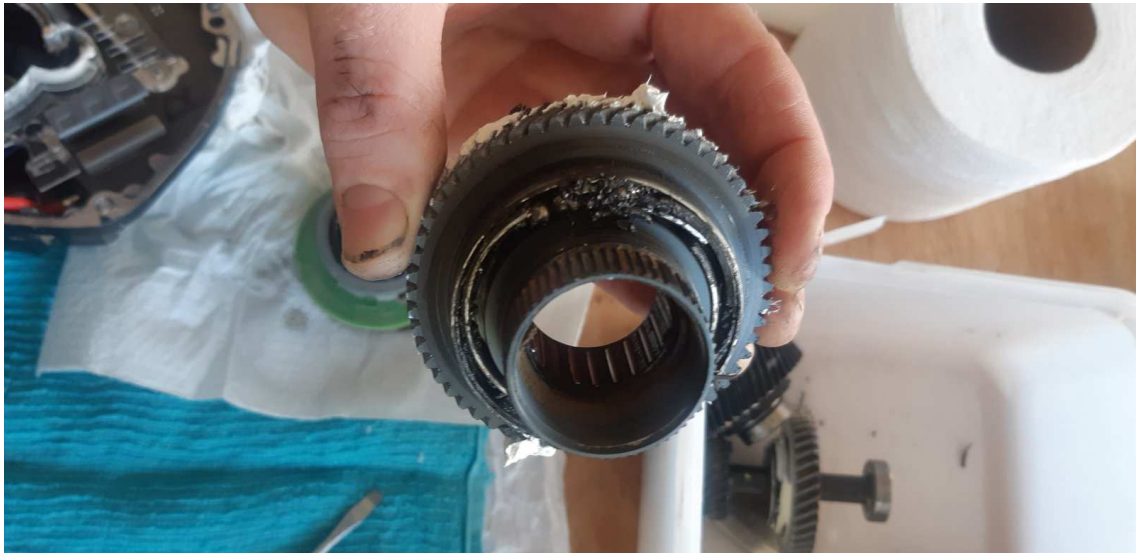
There are 6 standard bearings and two cage bearings (all of them are listed in following pages), but the two large bearings located in the crankshaft are the ones that suffer the most from water and dirt ingress and also from impacts when cranks hit rocks or branches, and they are more likely to break or get damaged.

So in case that you hear a grinding noise or you feel that the cranks do not rotate smoothly while rotating in any direction, then it is likely that one of your crankshaft bearings is shot.

If you replace the damaged bearing when it starts to fail and before it collapses, then you may avoid that this damaged bearing causes a bigger or even un-repairable damage to the motor. In the case below, the shot bearing damaged the housing in case, and now it is required to change the motor housing from a donor motor.

Damaged Bearing and below the damaged bearing housing in the motor case

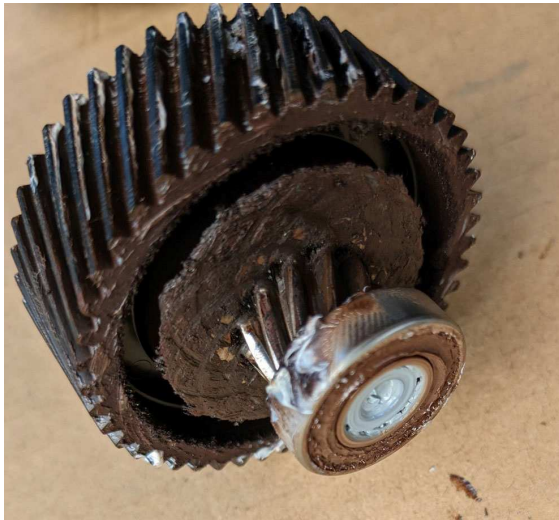
The issue for Motors Versions from manufacturing period 2019 - 2020 (TBC) is that some of the sprockets move and tilt along the shaft and interfere with other sprockets, causing to rub and grind against each other thus resulting in lower performance, higher battery usage and a temperature increase inside the motor. As a consequence, the grease inside the motor used to lubricate the sprockets reaches a too high temperature and degrades, losing its lubricating properties, transforming itself in a thick black gum, and then the lack of lubrication causes teeth of the sprockets to become damaged.

Sprocket with degraded grease transformed in gum:

Some forum members tried to fix the issue by opening the motor periodically to clean the grease and add fresh grease to sprockets and bearings, but this does not fix the main issue and the problem reoccurs shortly. The definite fix is to substitute the sprockets with parts from a donor motor that does not suffer this design issue.

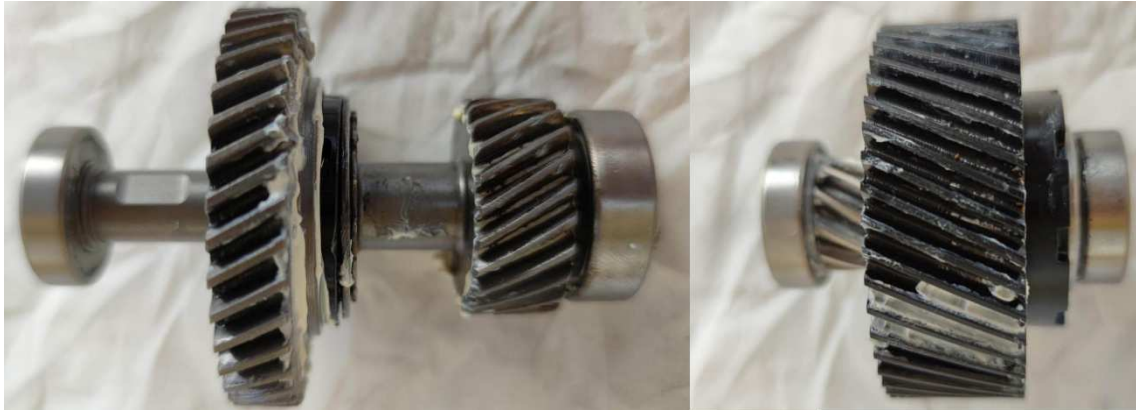
There are four small bearings on the sprocket shafts: 6000ZZ (10x26x8mm) and 3 x 6900ZZ (10x22x6mm, but these don't usually get damaged).

The left large sprocket has inside a directional roller clutch (Sprag clutch) (All motor versions), the right large sprocket has another sprag clutch (ONLY early motor versions, later versions do not have it). If you do require to access sprag clutch rollers it, you will need to remove a circlip. These are Shimano specific and not available, so if they break you have to from a damaged donor motor.

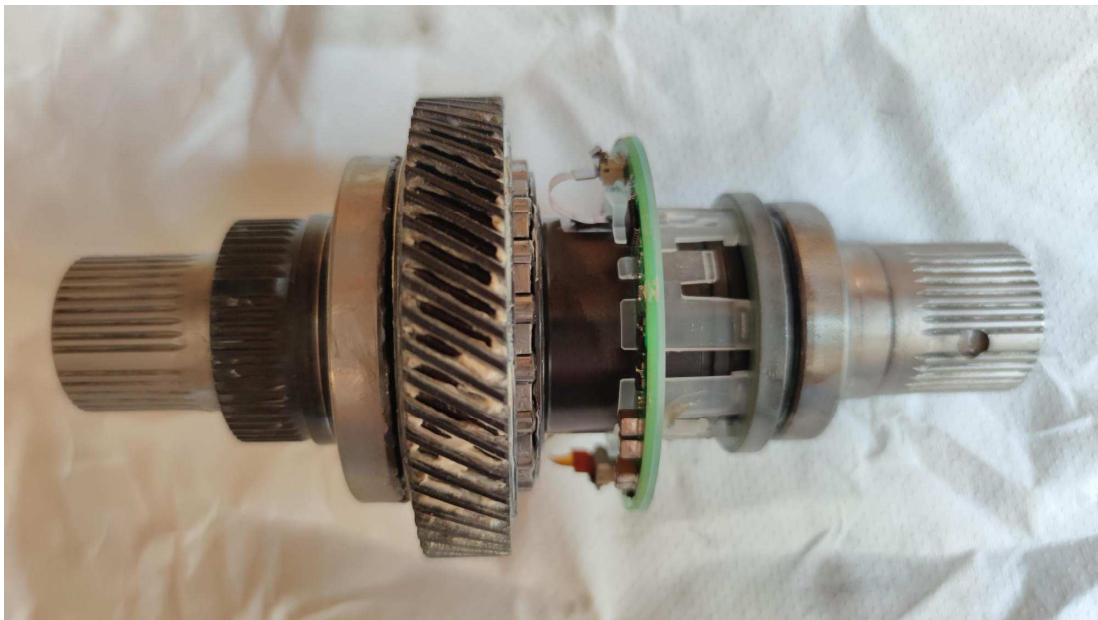
There are two larger bearings in the crankshaft and they may become damaged in case water gets its way through the case seals

- On the left side of the bottom bracket is bearing 6808D (40x52x7mm) with a brown (rubber) sealing gasket.
- On the right side is the 6805Z (25x37x7mm) bearing that has a metal seal that has less friction but also less protection against water ingress and that is the reason why this bearing usually causes problems. You will notice when it is damaged because it makes a grinding noise and doesn't turn smoothly.

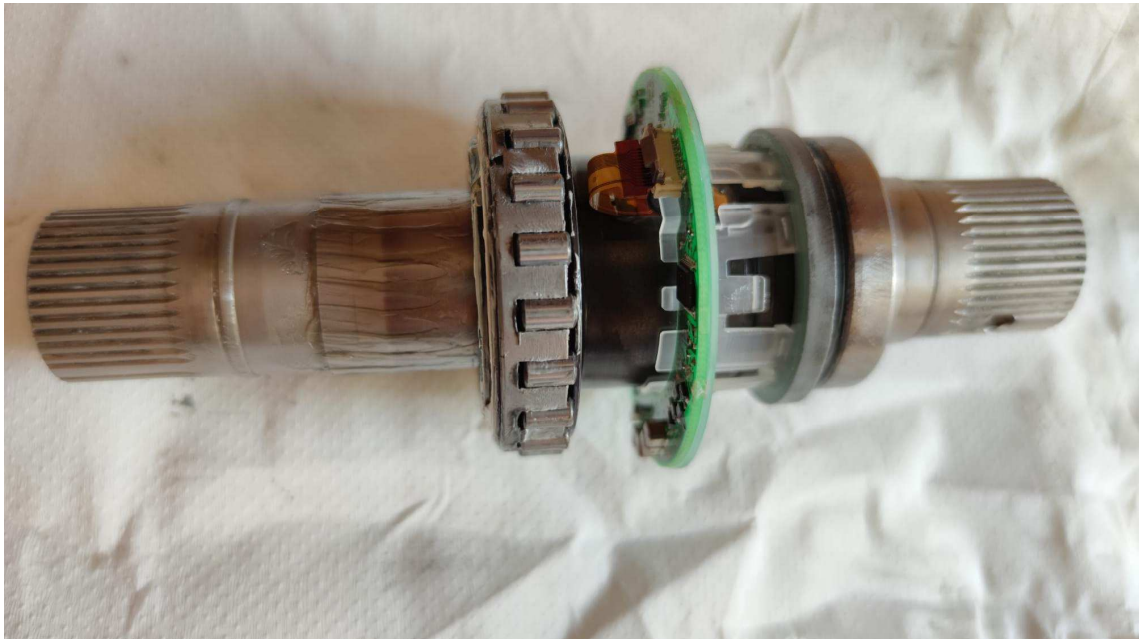
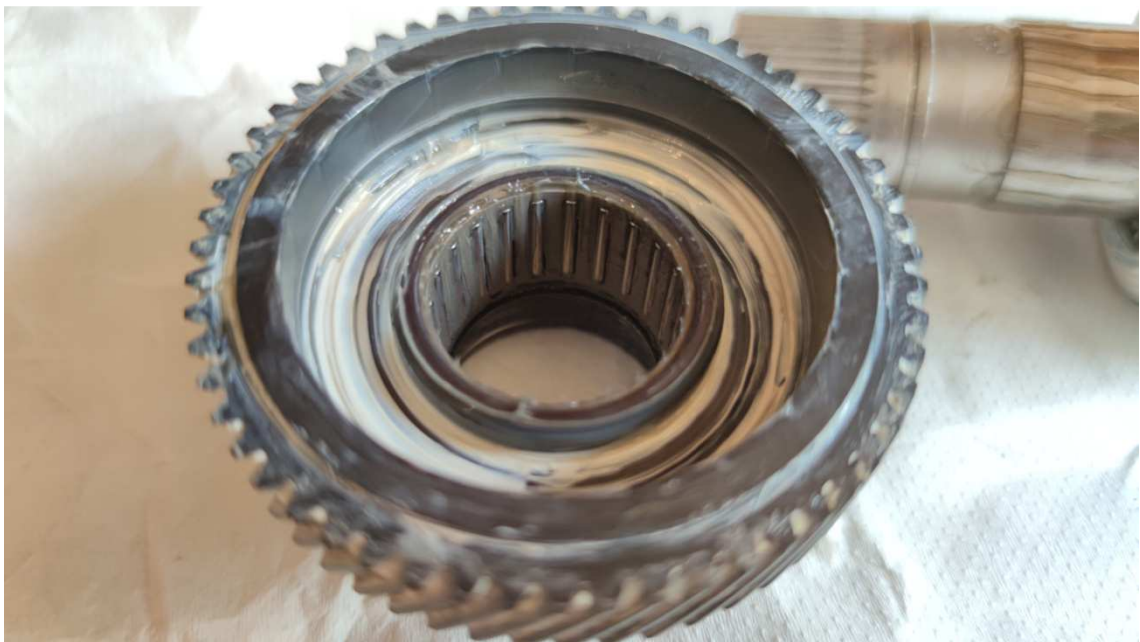
The large sprocket in the crankshaft can be disassembled easily just by pulling it from the crankshaft, and you'd get these:

Now the sprocket has been separated from the internal Sprag Clutch and its rollers. It can be seen a Cage Roller Bearing inside the sprocket that normally does not get damaged and can be greased with white lithium grease. BUT for Sprag Rollers it shouldn't be used White Lithium grease, it is required a grease with less density as it will be explained later.

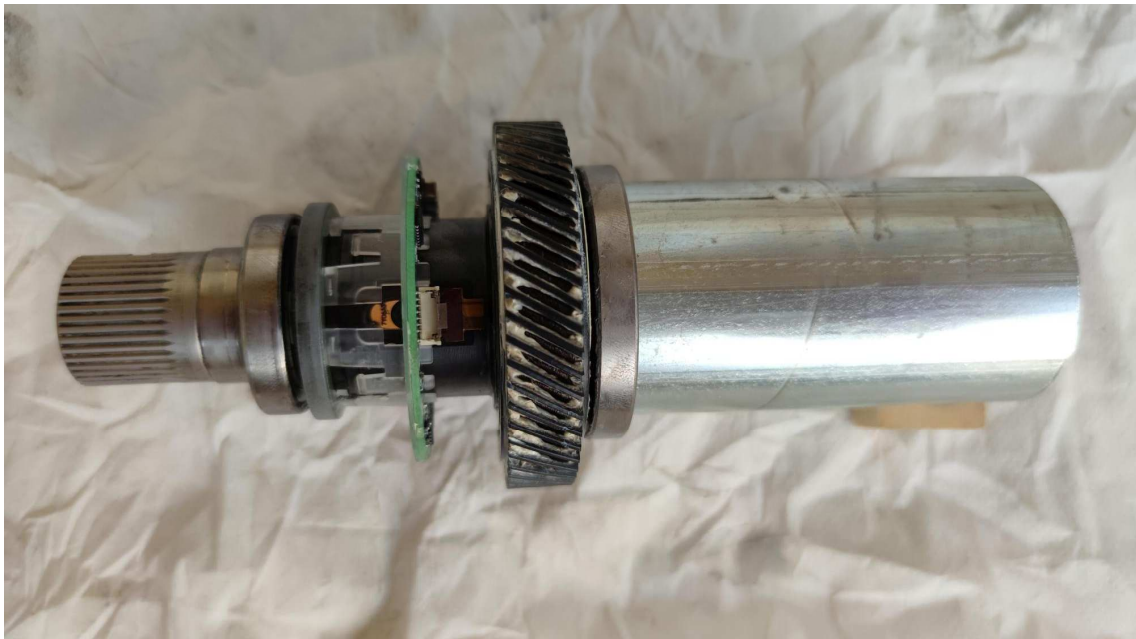
To insert the new bearings you'll need a small hammer and a puncher to insert the bearing by gently tapping the puncher ON THE INNER RACE OF THE BEARING while rotating the tapping point around the perimeter every quarter turn until it settles. A better choice might be to use metal tubes to press them in place using a vice or a large diameter long bolt. There may be a special tool or bearing press, but I don't know about it.

Using a metal tube with 41-42mm inner diameter to press the bearing in place

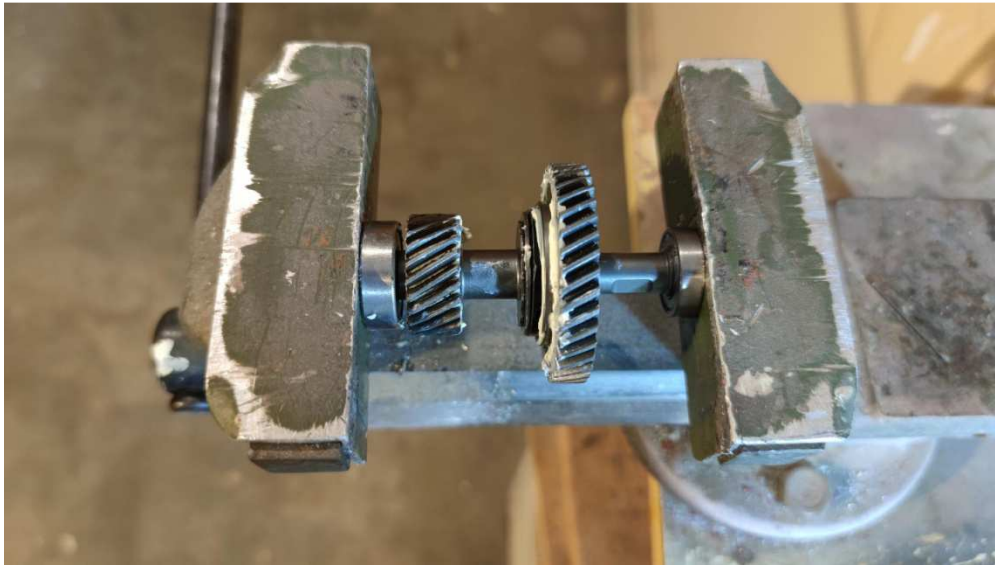
The bearing can be pressed in place using a vice:

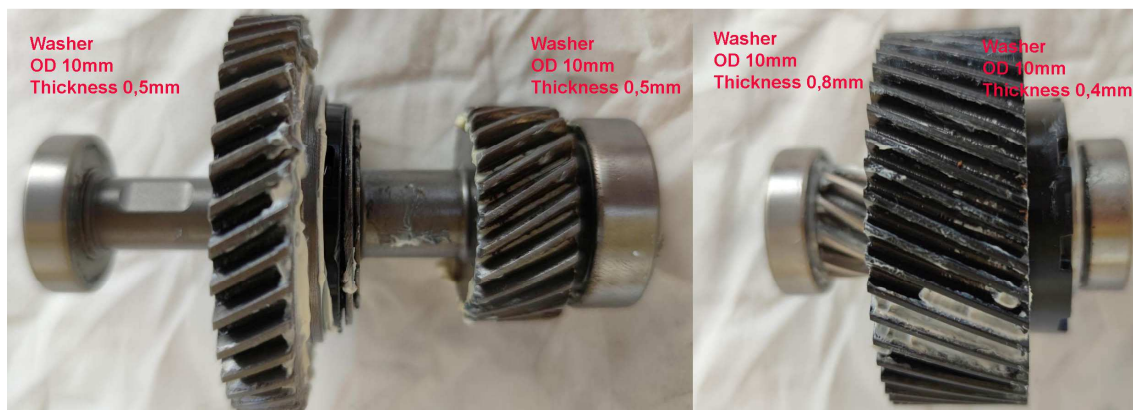
BUT the bearings inner race are not aligned with the shaft end, that is, the bearing protrudes from the shaft 0,5 or 0,8mm, depending on the bearing position, to get this spacing, it could be used a thin washer with OD 6 or 8mm, depending on the bearing inner race diameter, this washer is inserted inside the bearing inner race while it is pressed in the vice.

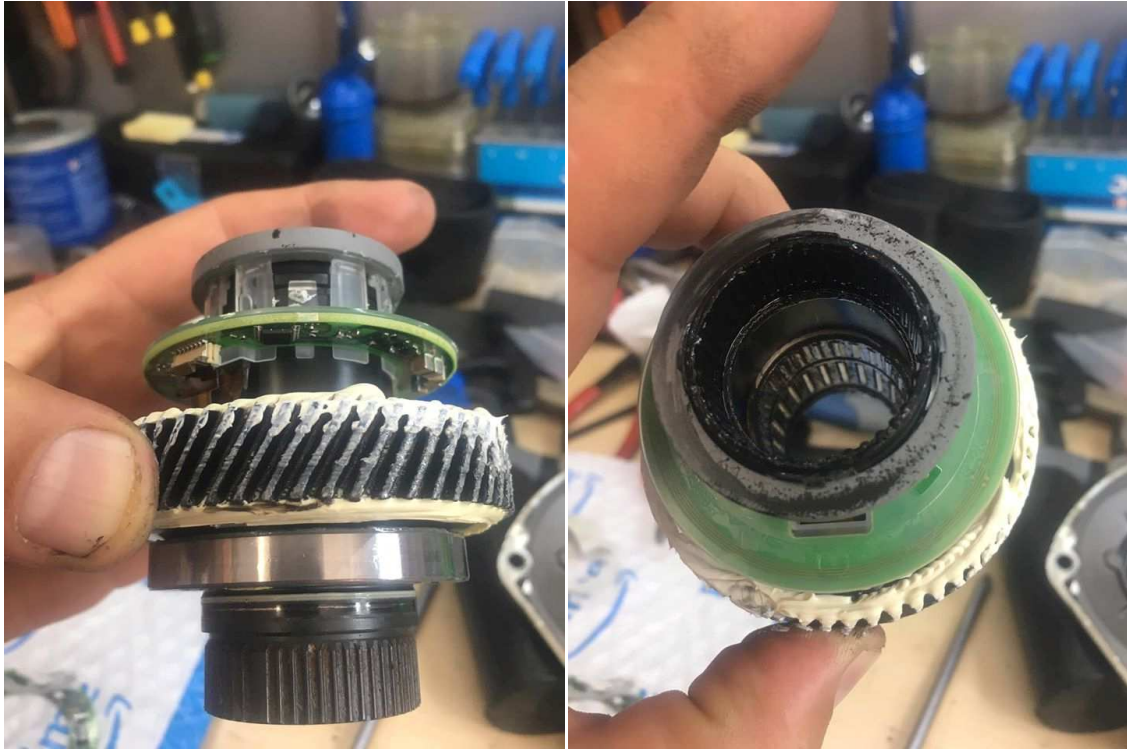
The main shaft with the roller bearings, where the bottom bracket is inserted

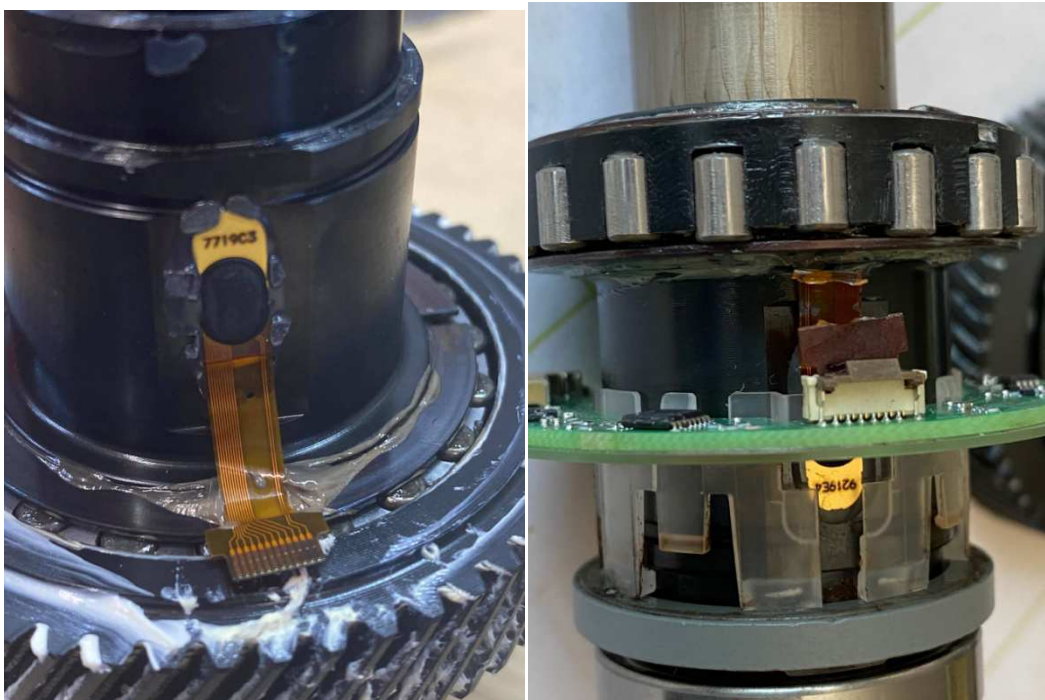
In the first photo we see the torque sensors that are of the "Strain Gauge" type and are bonded to the shaft with putty. In the second photo we see the rollers of the Sprag- clutch which us inside the black sprocket.
